SITE INSPECTION
OF
BLACK AND DECKER, INCORPORATED
PREPARED UNDER

TDD NO. F3-9101-19
EPA DSN MD-370
FACILITY ID NO. MDD003065877
CONTRACT NO. 68-01-7346

FOR THE
HAZARDOUS SITE CONTROL DIVISION
U.S. ENVIRONMENTAL PROTECTION AGENCY

OCTOBER 9, 1991

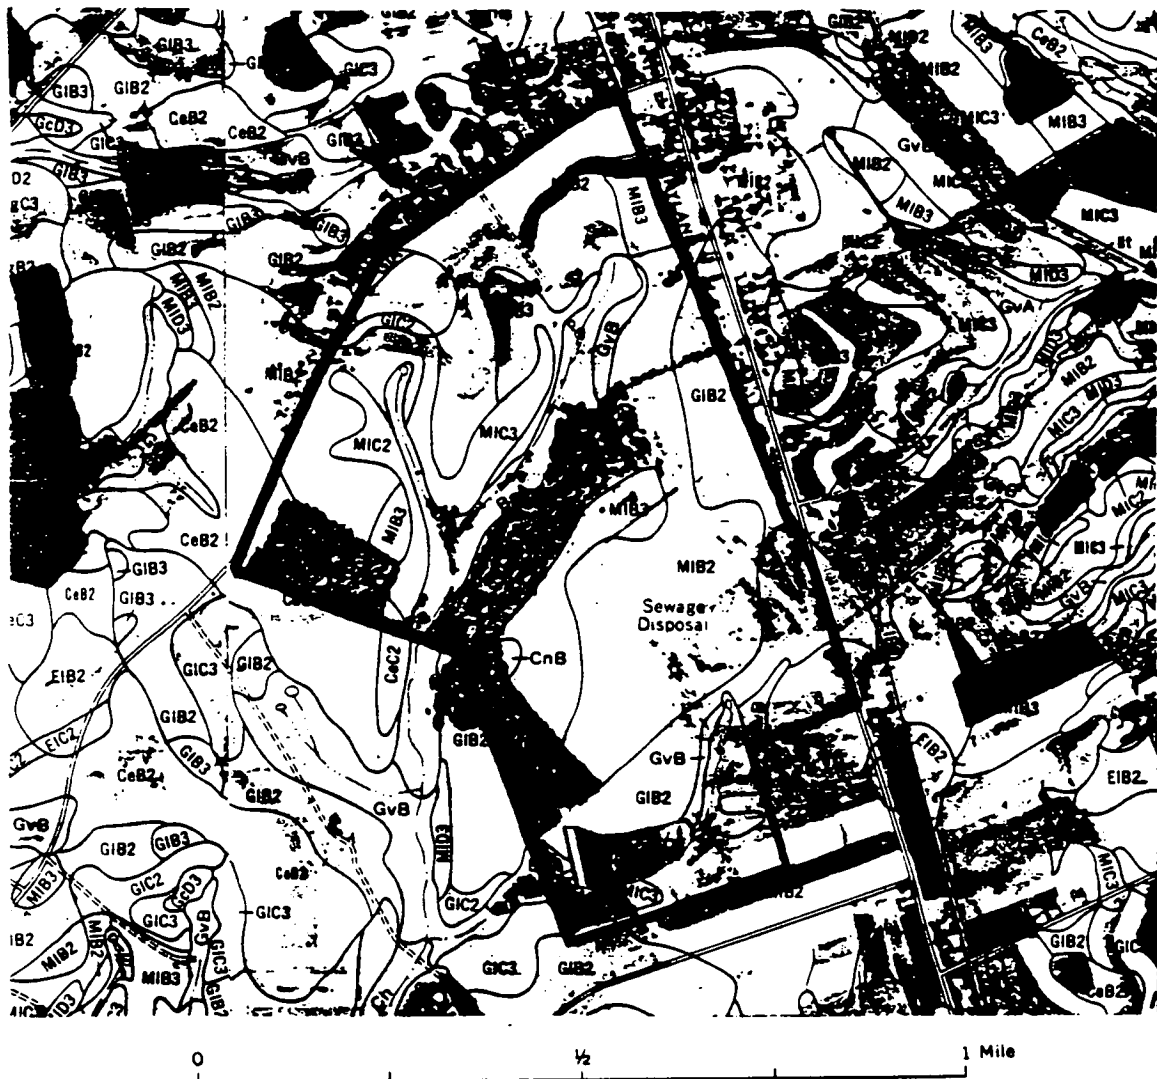
FIGURE 3.2

The soils that occur at the site belong to six soil series that are typical of the Piedmont Upland in Maryland (see figure 3.2, page 3-7). Site-specific data may be obtained from the soil boring logs (see appendices P and W). The soils at the site appear to be generally undisturbed except for the impact caused during the construction of the facilities. The most prevalent series is the Manor loam, which occurs on slopes ranging from 0 to 15 percent, with moderate to severe erosion. The Manor loam series consists of deep, very well-drained soils of level to steeply sloping uplands. It typically consists of an organic horizon that is a dark brown loam, one to four inches thick. The subsoil is red to yellowish-brown loam and may contain quartzite, mica, or schist fragments and is 17 to 30 inches thick. The substratum is an extremely micaceous, variegated loam saprolite. The permeability of this series is moderately rapid to rapid (two to 6.3 inches per hour) throughout all horizons in the profile. The soil reaction is very strongly acid to strongly acid (pH, 4.0 to 5.5) from 0 to 23 inches below the surface and very strongly acid (pH, 4.0 to 5.0) from 23 to 90 inches below the surface.^{6, 22, 27, 34, 56}

SOILS MAP
BLACK AND DECKER SITE
Carroll County, Maryland

The Chester silt loam series (CeB2, three to eight percent slopes) is a deep, well-drained soil of level to sloping uplands. It commonly occurs at the crests of ridges. The organic surface layer is dark brown silt loam, 8 to 10 inches thick. The subsoil is yellowish-red clay loam that becomes more silty and micaceous with depth. This horizon is 28 to 45 inches thick. The substratum is a variegated loam saprolite. The permeability of this series is moderate (0.63 to two inches per hour), respectively, for the surface layer and the subsoil. The substratum permeability ranges from moderately rapid to rapid (two to 6.3 inches per hour). The soil reaction is strongly acid (pH, 5.1 to 5.5) in the surface layer, very strongly acid to strongly acid (pH, 4.5 to 5.5) in the subsoil, and very strongly acid (pH, 4.5 to 5.0) in the substratum.⁵⁶

The Baile silt loam series (BaA, three to eight percent slopes) consists of poorly drained soils of upland depressions and at the footslopes of drainageways. The surface organic layer is dark gray silt loam, seven to nine inches thick. The subsoil is gray, mottled heavy silt loam, 26 to 39 inches thick. The substratum is greenish-gray, highly micaceous saprolite of loam texture. The permeability of this series is moderately slow to moderate (0.2 to 0.63 in the per hour) in the surface layer and slow (less than 0.2 inch per hour) throughout the remainder of the profile. The soil reaction ranges from very strongly acid to strongly acid (pH, 4.5 to 5.5) in all horizons.⁵⁶
